# Water Resources of Beaver Creek National Wild River

Stream Gaging Data from 1993 to 2000 with Summary  
Statistics

**BLM-Alaska Open File Report 102**  
September 2005

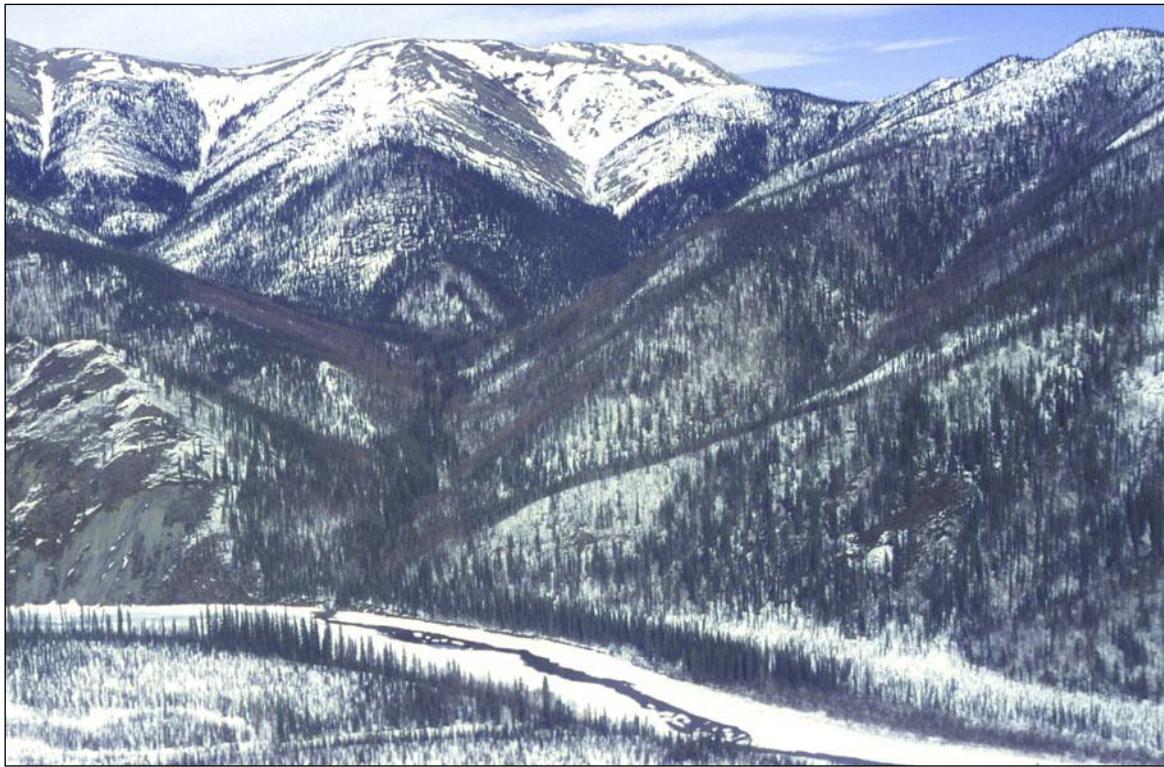
**Figure 3.** Beaver Creek is normally ice-covered for most of the winter, but groundwater springs keep a few reaches of the creek open all winter.

of about 12 inches of rainfall for the summer period. Freeze-up on streams often begins at higher elevations in mid-September, although larger streams lower in the basin may remain open until November. Ice cover on streams is usually continuous for the winter, except in the vicinity of springs, and freezing to the bottom of the channel may occur in some places (Figure 3).

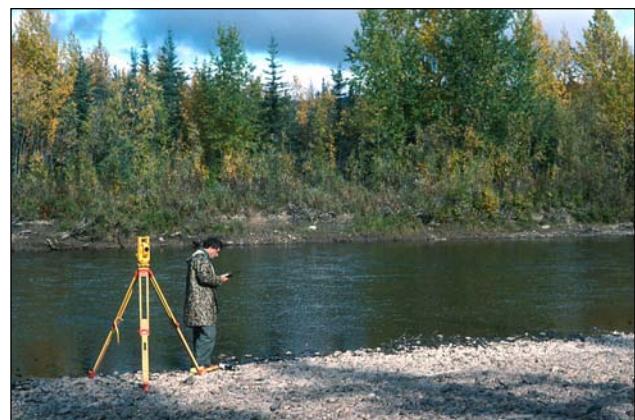
**Figure 5.** While most surveying employed a level and stadia rod, multi-cross-section surveys were often done with a total-station theodolite.

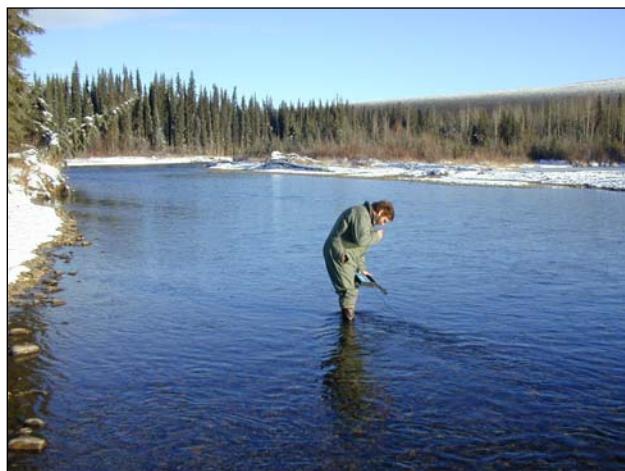
**Figure 6.** Water-quality readings were taken in-situ with single parameter meters.

parameter meters (Figure 6).

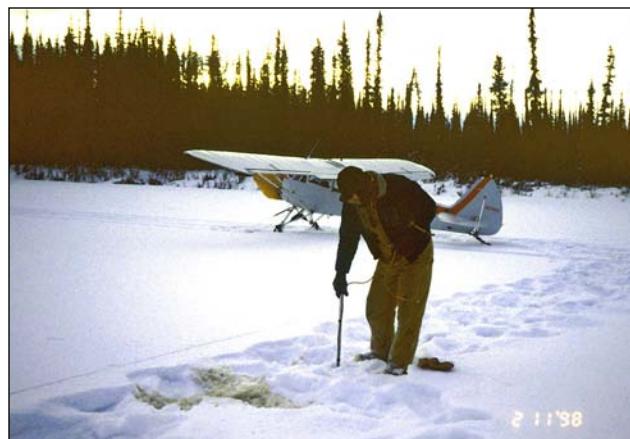
**Figure 7.** Winter discharge measurements were needed to document under-ice flows, critical to over-wintering fish.

measurements were made by drilling a series of holes in the ice to define the cross-section, then measuring the depth and velocity in each hole using a USGS vertical-axis, vane type current meter mounted on a graduated rod (Figure 7).

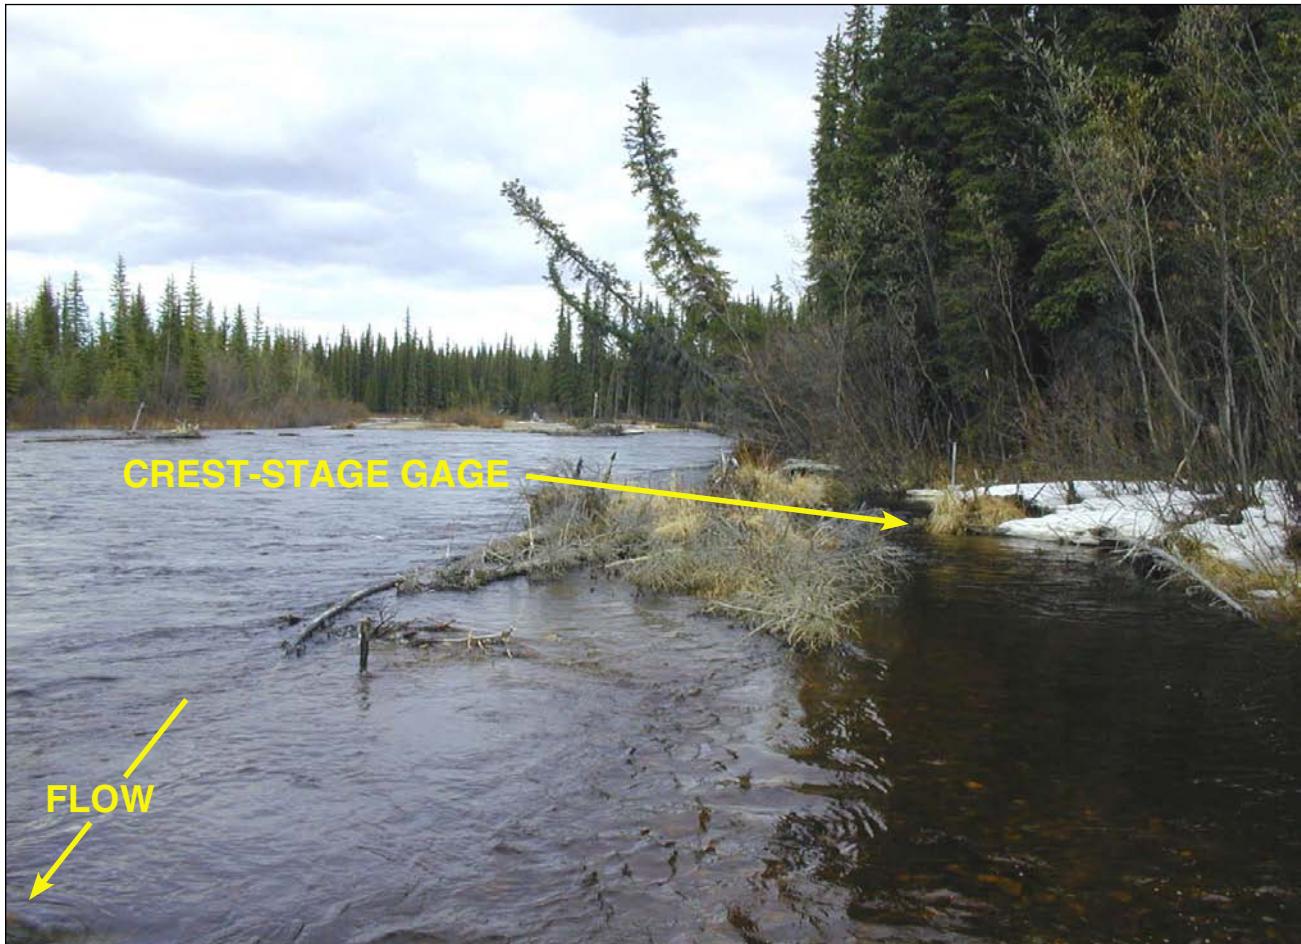
**Figure A-1.** Looking upstream at the crest-stage gage at Beaver Creek above Nome Creek. The gage was installed in 1989 and discontinued September 1999.

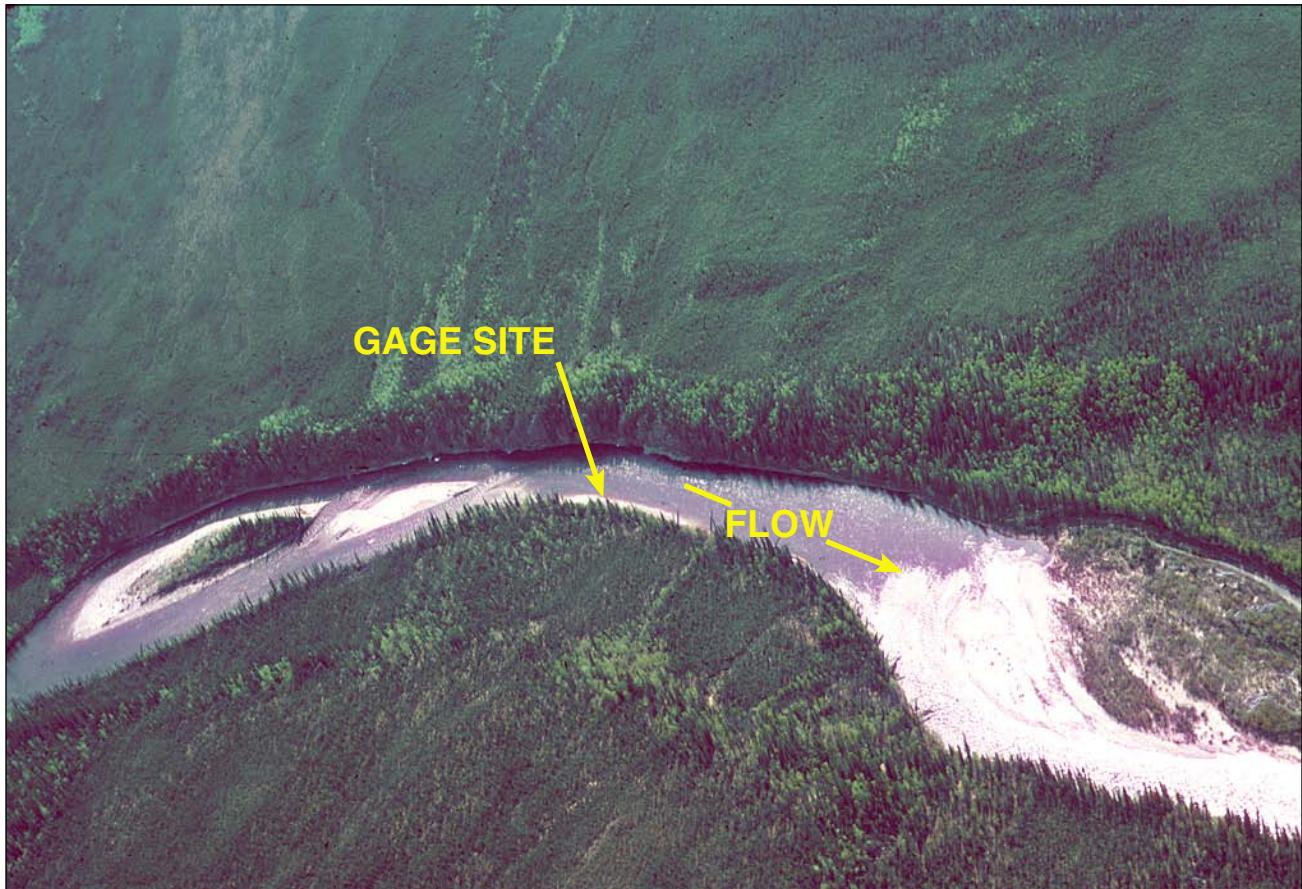
**Figure A-5.** The site at Victoria Creek below Squaw Creek was selected in September 1989. A crest-stage gage was installed in June 1990 on the right bank. Data was collected until 1995, when the gaging project was discontinued. The gage was removed in September 2000.

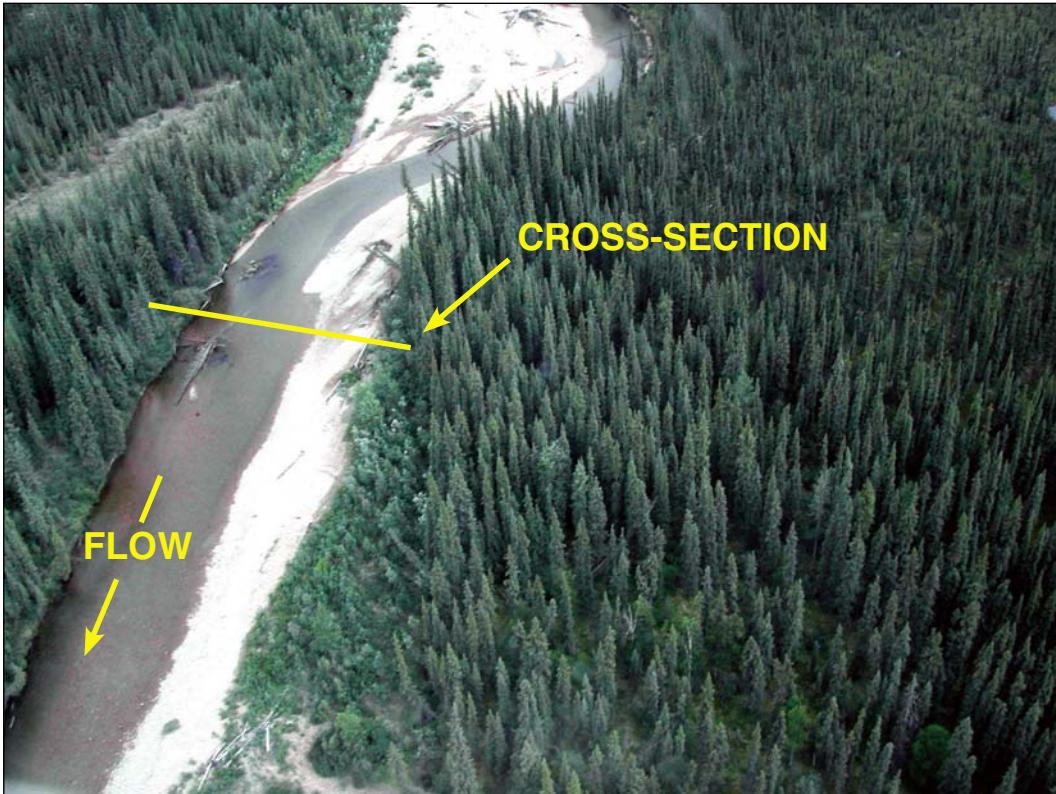
**Figure C-1.** View of stream channel for Beaver Creek above Nome Creek in July 2003.

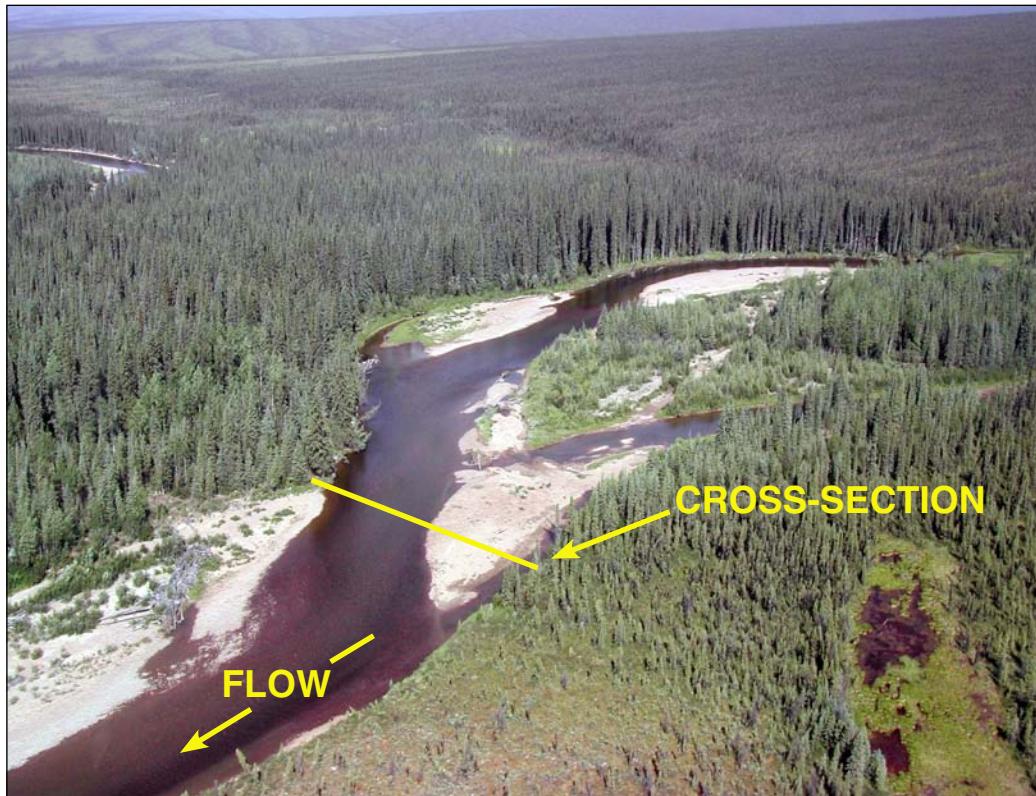
**Figure C-3.** View of stream channel for Beaver Creek below Nome Creek in July 2003.
